**TYPICAL PHOTOGRAPHS OF MÉLANGE MATRIX:
BOREHOLE LB-03**

Downtown Extension Project
Transbay Joint Powers Authority
TJPA
San Francisco, California

April 2007

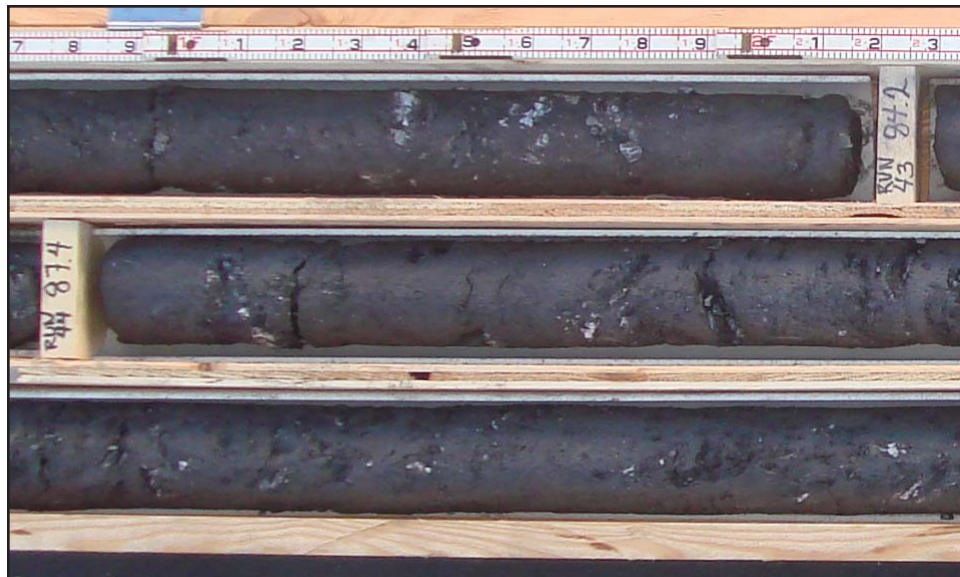
Picture 1:
Typical core of Mélange Matrix, as recovered in the field.

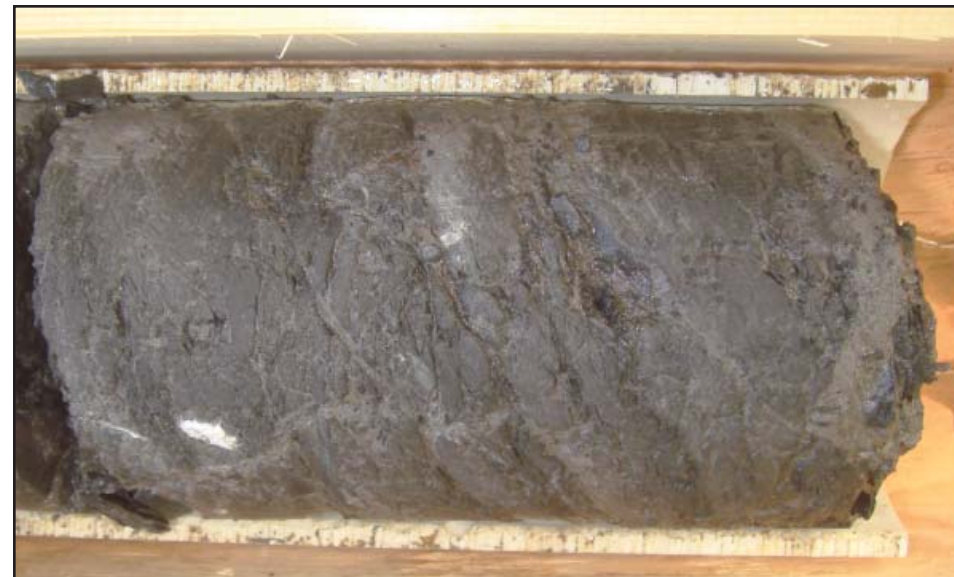
Picture 2:
Close-up view of core recovered from borehole LB-03.

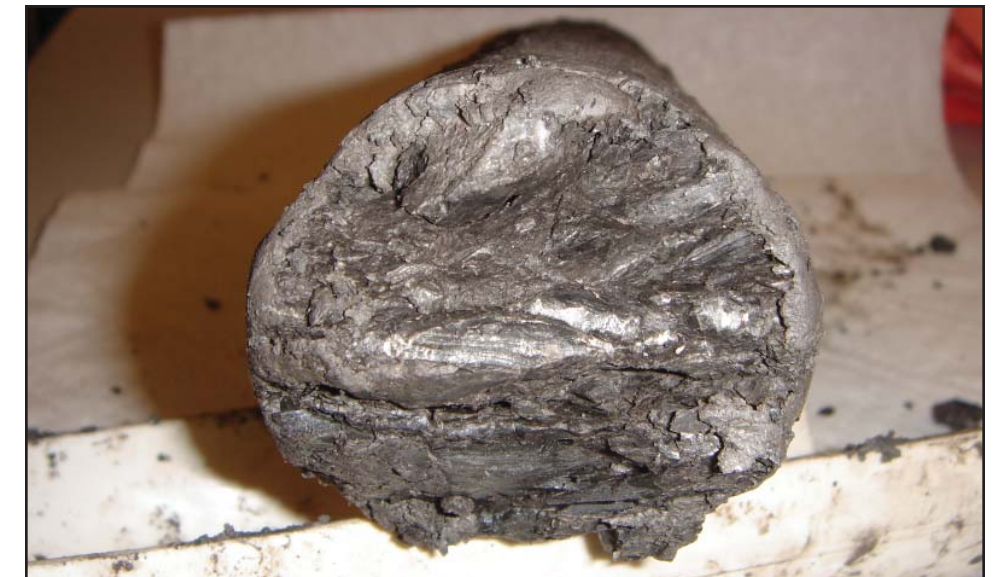
Picture 3:
View of core cross section illustrating irregular contacts between different materials, and laminated structure.

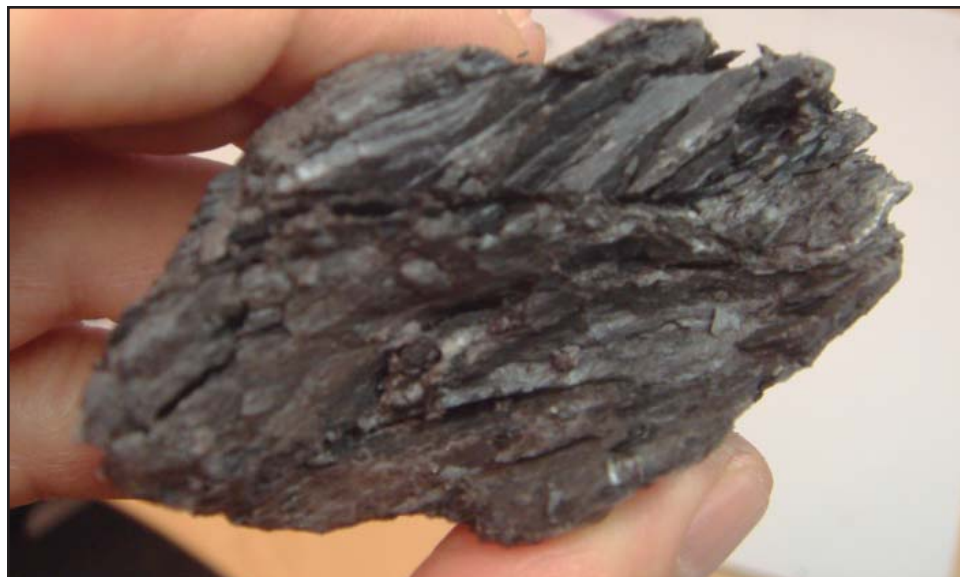
Picture 4:
Close-up view illustrating contorted and laminated structure.

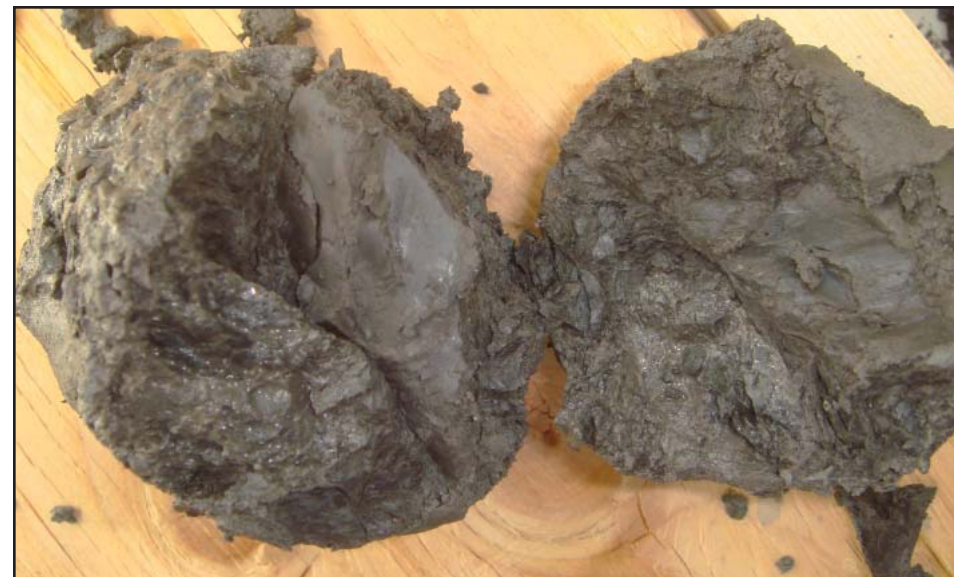
Picture 5:
Close-up view illustrating evidence of shear deformations and slickensides.

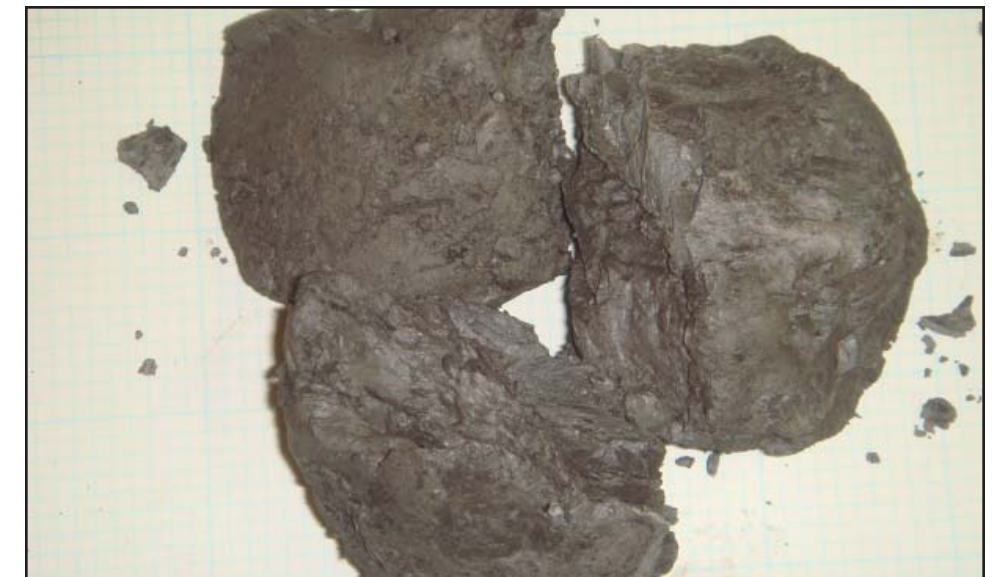
Picture 6:
Close-up view that shows the presence of slickensides.
