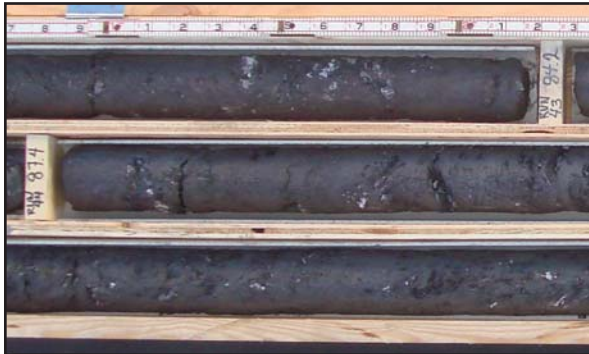
Picture 1:
Typical core of Mélangé Matrix, as recovered in the field.

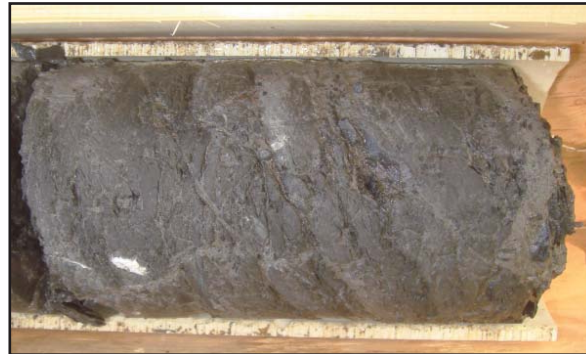
Picture 2:
Close-up view of core recovered from borehole LB-03.

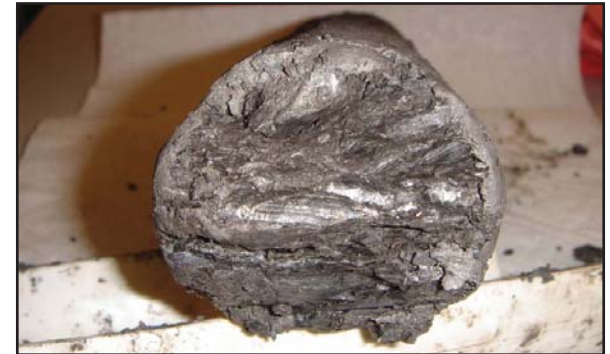
Picture 3:
View of core cross section illustrating irregular contacts between different materials, and laminated structure.

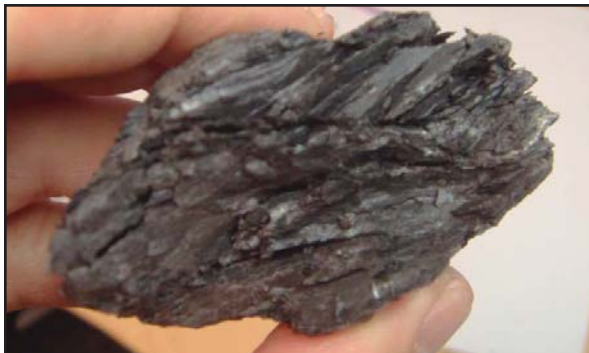
Picture 4:
Close-up view illustrating contorted and laminated structure.

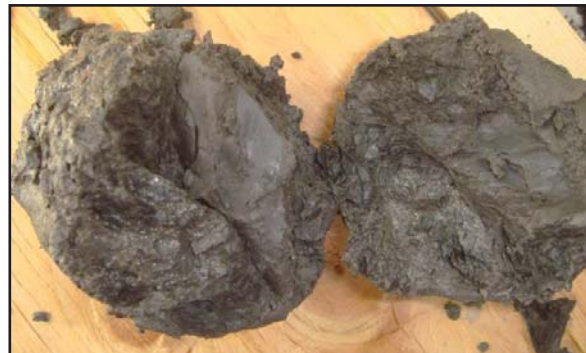
Picture 5:
Close-up view illustrating evidence of shear deformations and slickensides.

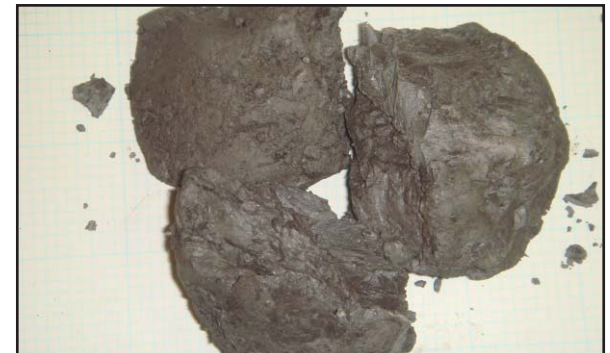
Picture 6:
Close-up view that shows the presence of slickensides.
