FIG_237: Lateral Deflections Versus Excavation Depth: Overflow Structure Along Islais Creek

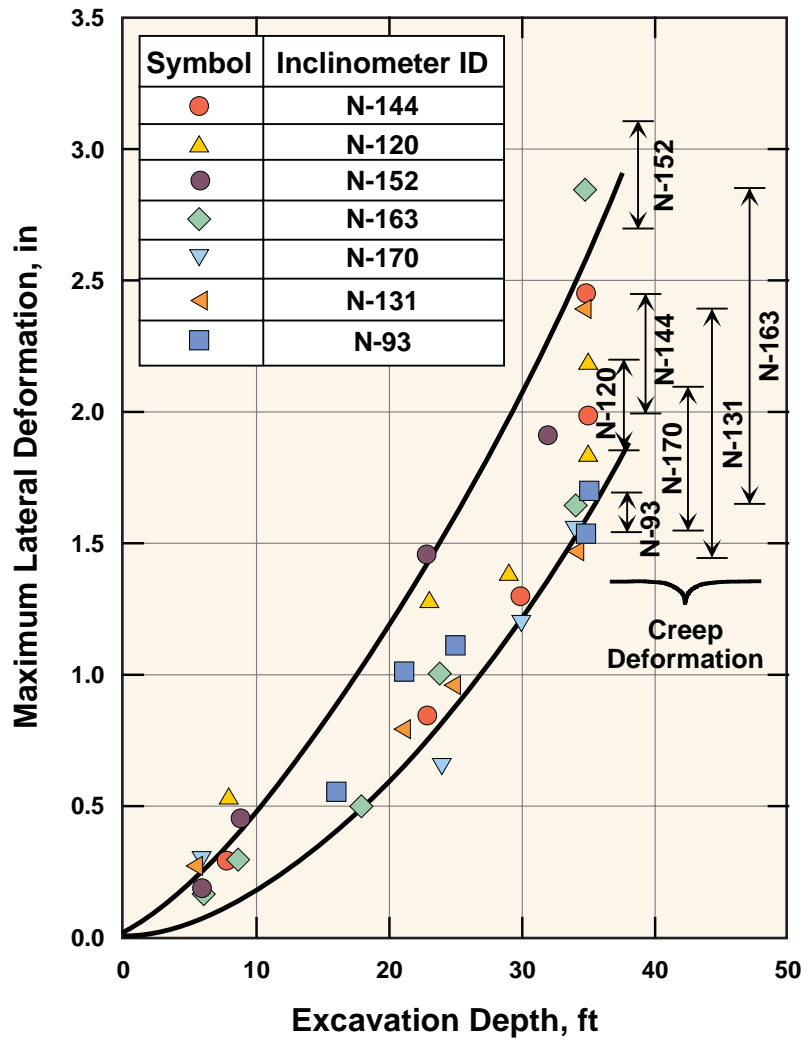
Deflection Behind North Wall

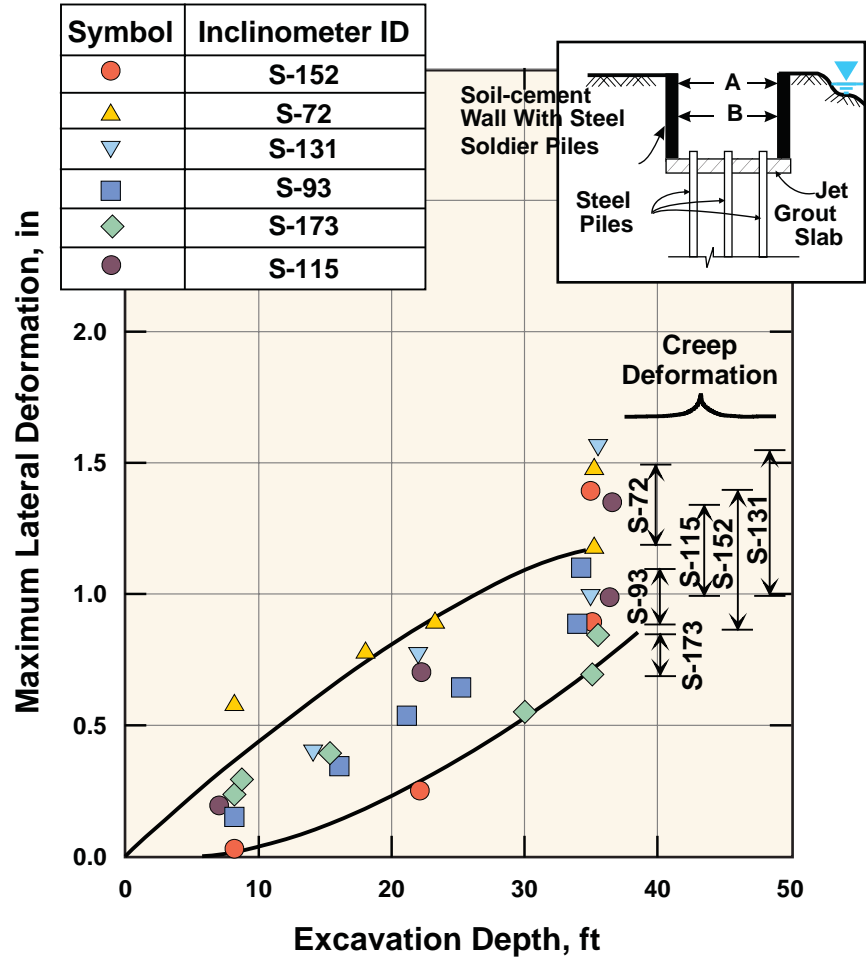
Deflection Behind South Wall
