**LATERAL DEFORMATIONS MEASURED WITH INCLINOMETER I-8, IN THE AREA BETWEEN MARIN AND ARMY STREETS**

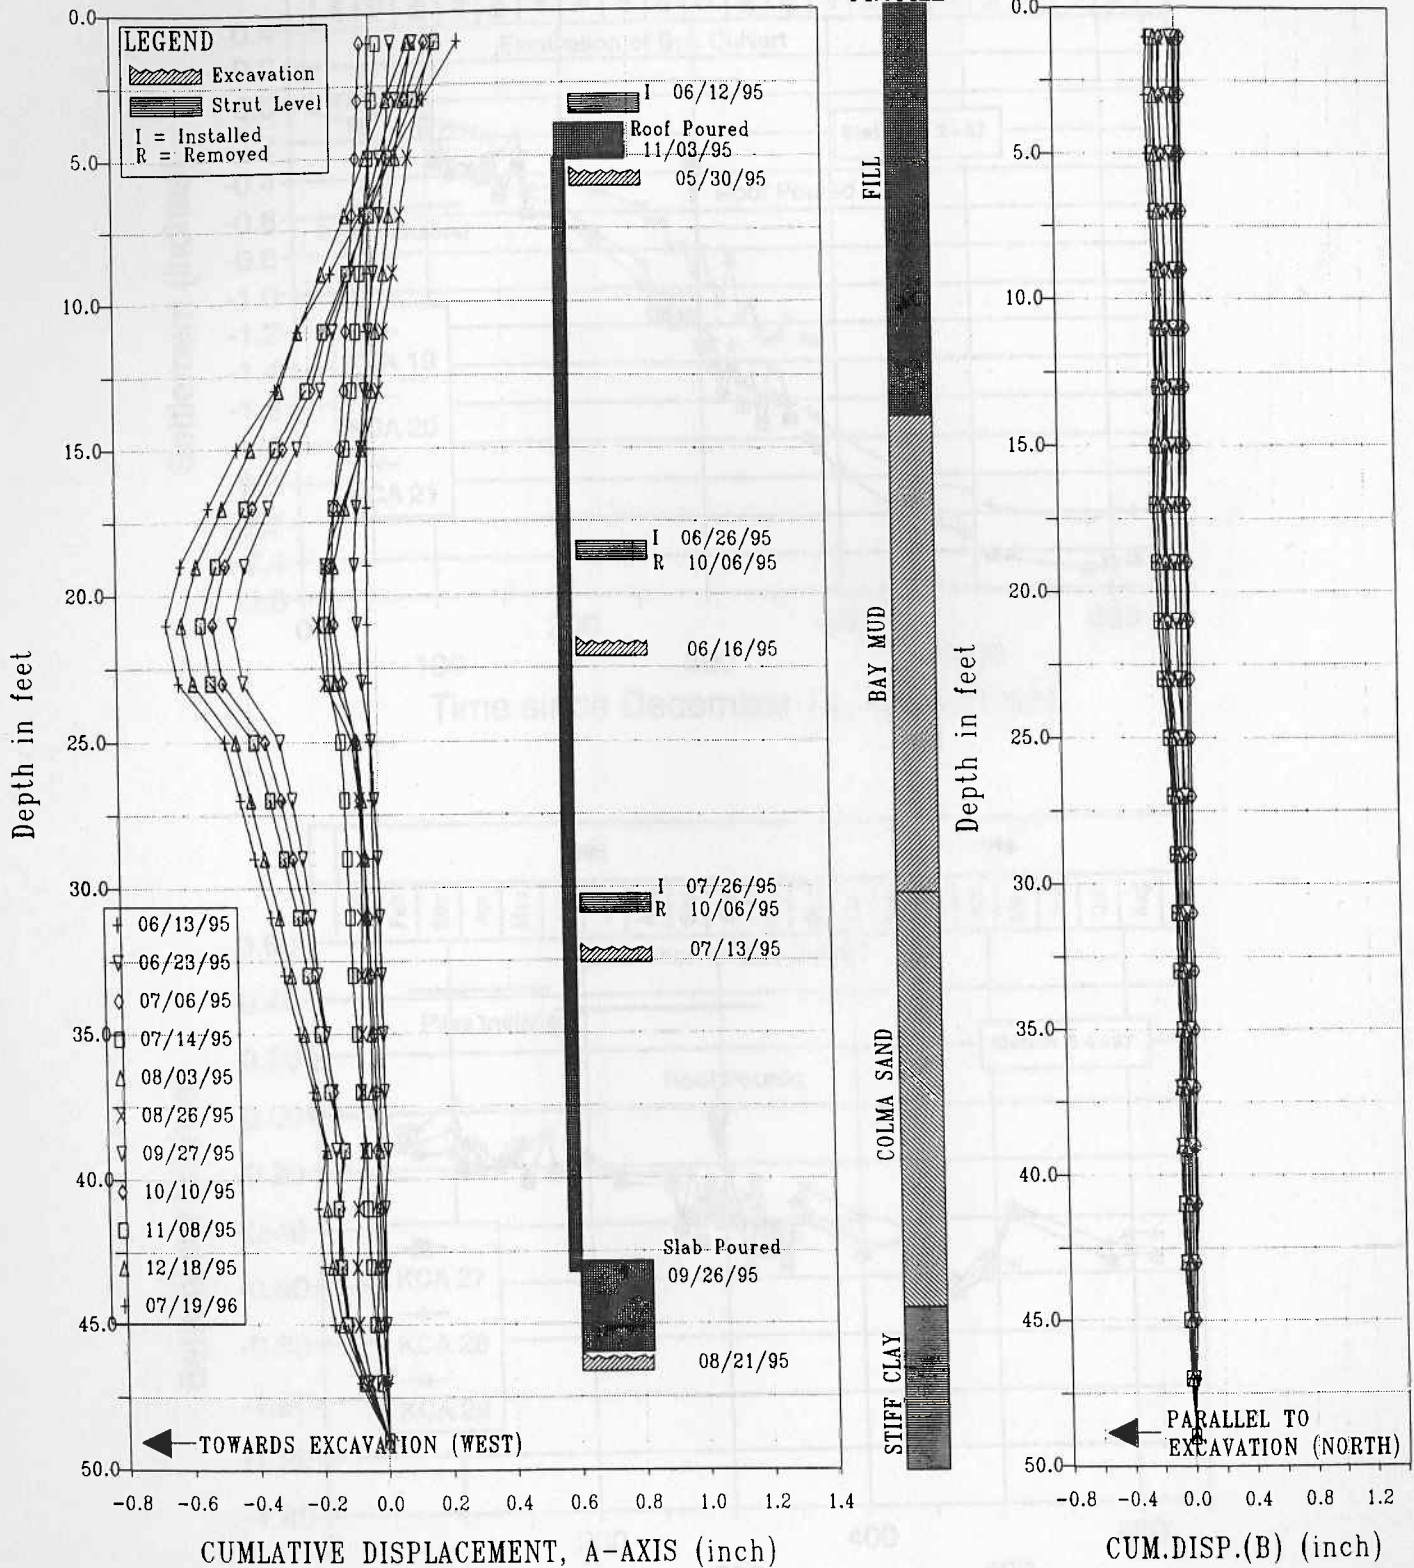
Perpendicular Direction

SUBSURFACE PROFILE

Parallel Direction

Base-Line Reading 06/09/95, After Start of Excavation
