FIG_210: Excess Pore Pressures and Lateral Pressures Caused by Jet-Grouting: Singapore Experiment
 W:\Infrastructure\Geotech\UC Berkeley 2008 Seminar\Final Figures\10 JET GROUTING (206-224)\FIG_210

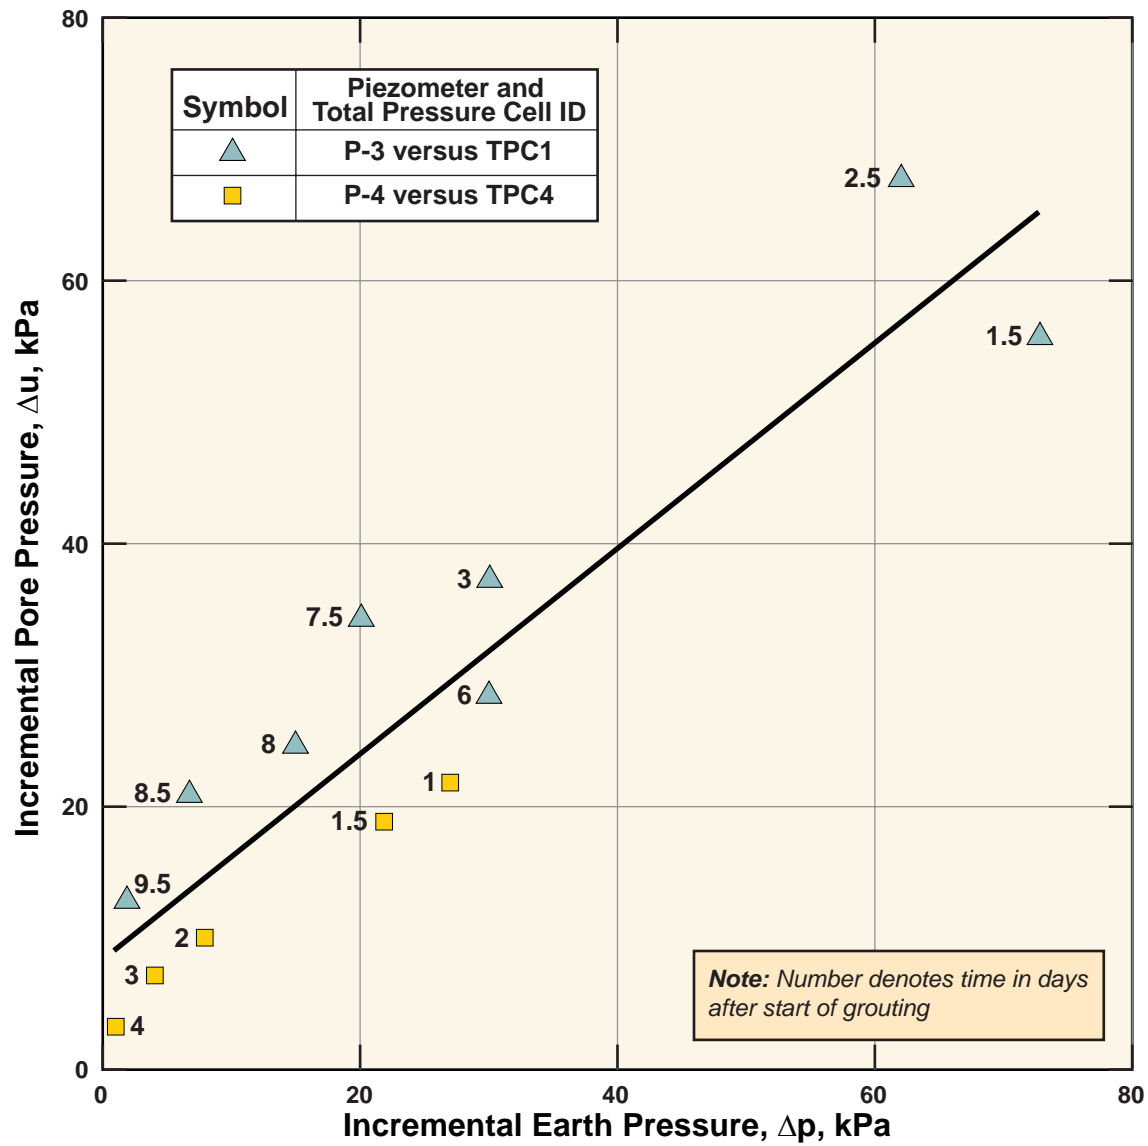
Poh and Wong (2001)
