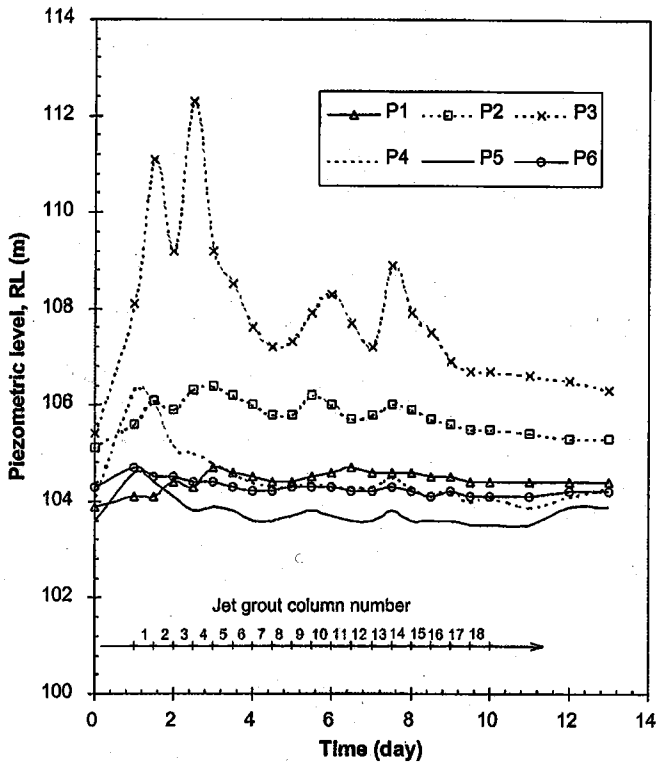
Fig. 9. Changes in piezometric level during jet-grouting trial.
